**NOTES ON SMUGGLING  
BY MEANS OF MOTOR VEHICLES  
AND ITS DETECTION**

**ILLUSTRATIONS AND DETAILS OF CONCEALMENTS  
OF CONTRABAND THAT HAVE BEEN DETECTED BY  
CONTINENTAL CUSTOMS OFFICIALS.**

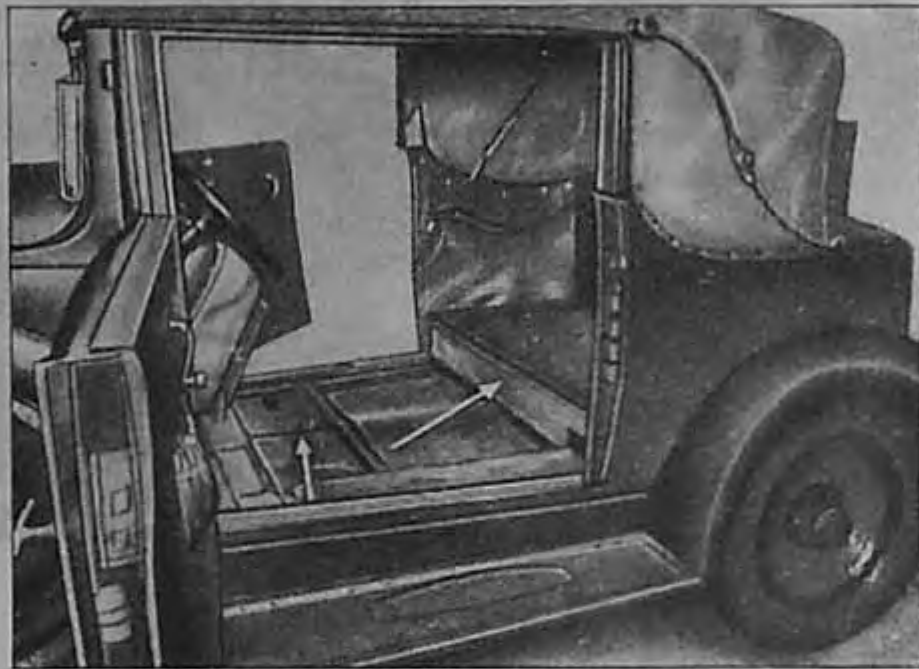
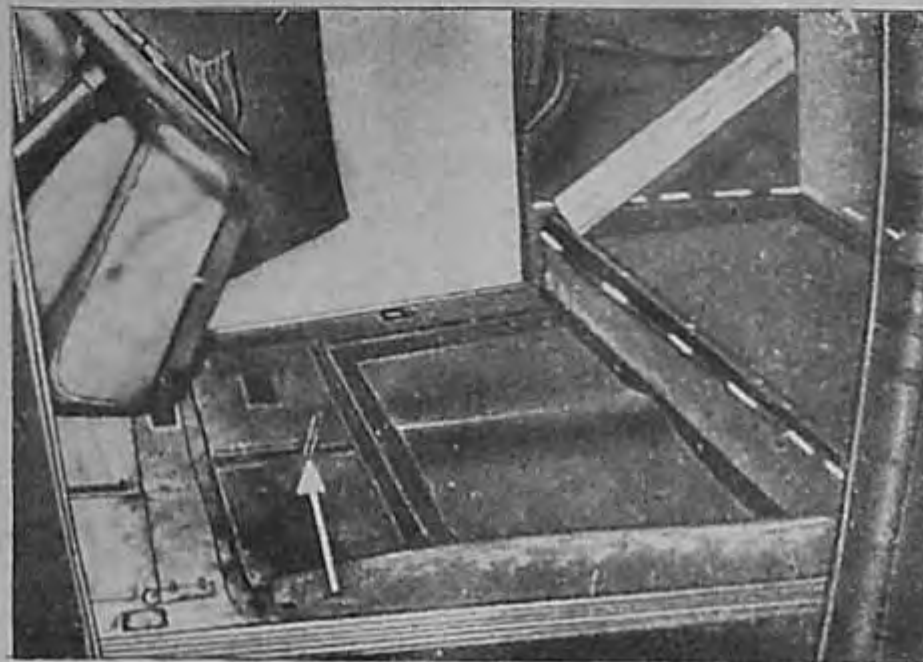
1. A concealment was found in a space constructed under the back seat of a Nash car.

When the back seat was removed a flat surface was seen which was apparently part of the normal construction. This firmly fixed covering plate was released by operating a small lever between the front seats, the contrivance being strongly spring loaded.

The lever was not seen until the front seats were removed.

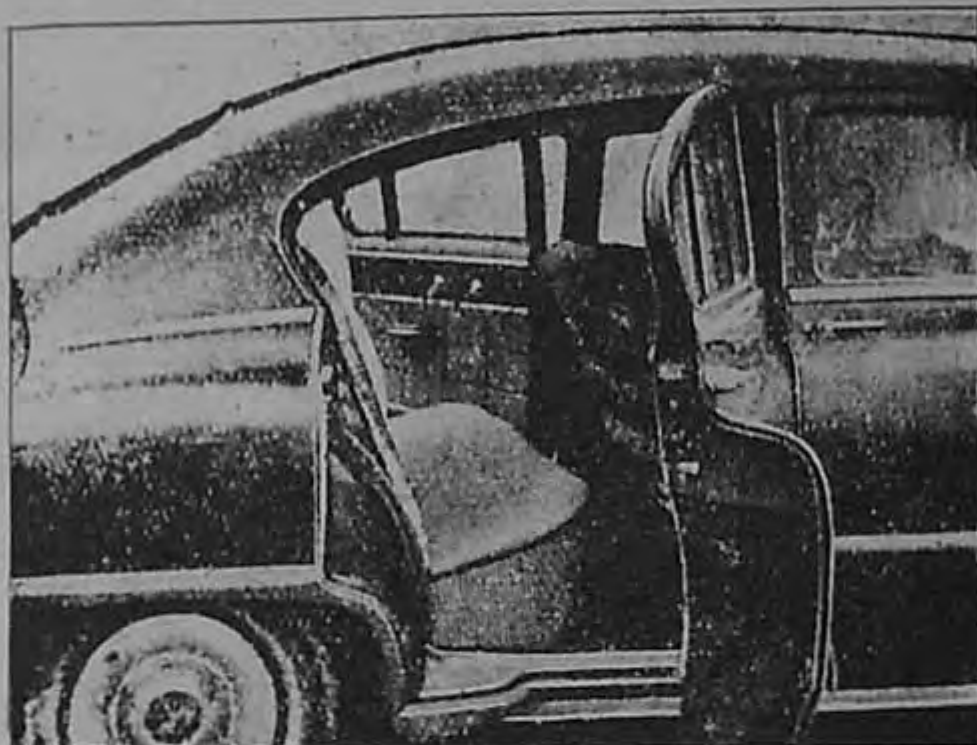
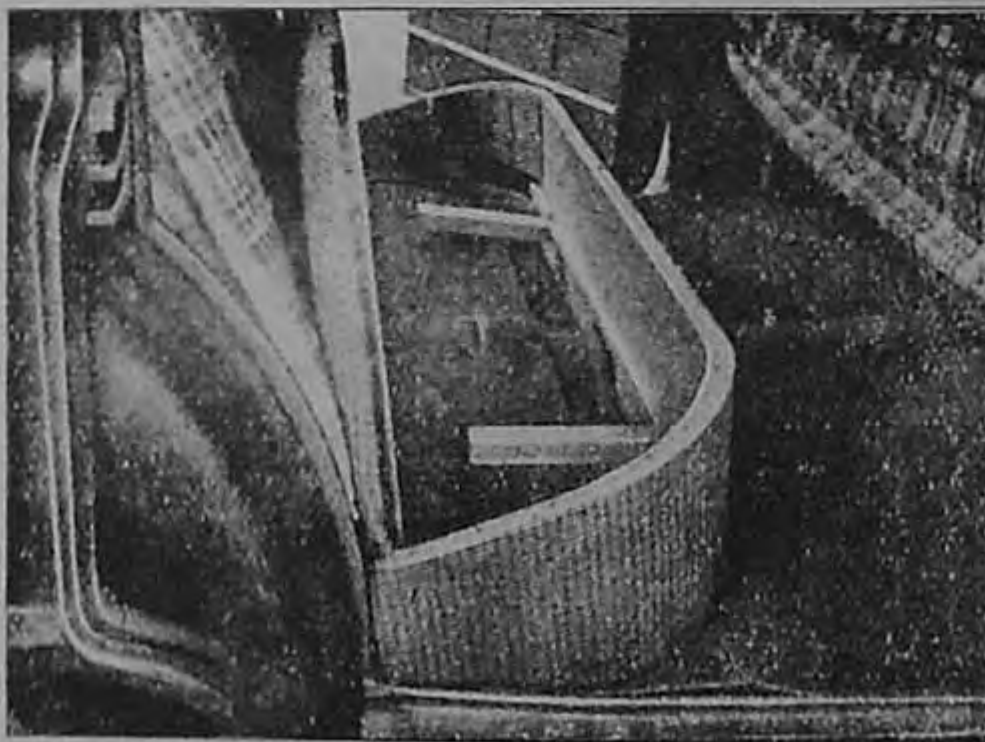
2. Another smuggling compartment was found under the back seat of a Pontiac motor car in which was found 50,000 (No) cigarettes, 2 computing machines, 7 bottles of spirits, nylon stockings and other goods.

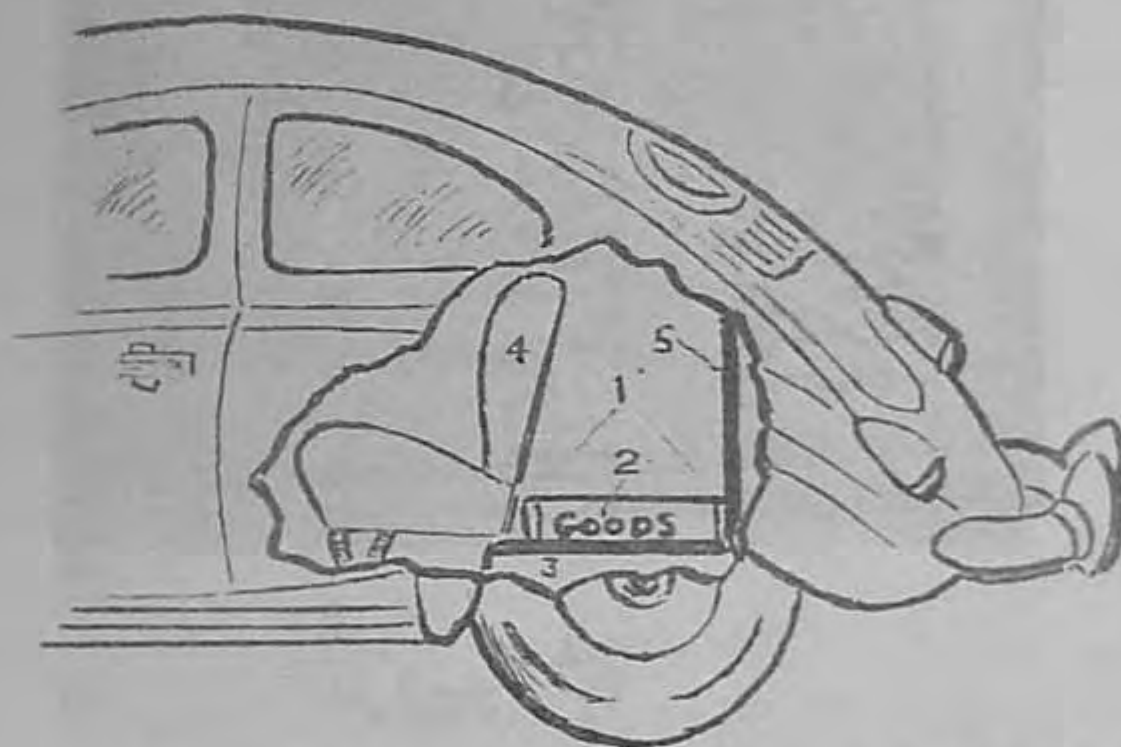
3. A secret container behind the rear seat of a Volkwagon car was found to contain 4,000 (No) cigarettes.

By means of two blocks of wood which were set on edge and a sheet of compressed fibreboard, made to fit exactly, the floor of the luggage boot was raised and formed a hiding place for contraband between the back of the rear seat and the fireproof bulkhead.

Access to the place of concealment was obtained by the forcible removal of the back of the rear seat.

1. WOODEN BLOCKS SET ON EDGE

2. SHEET OF FIBREBOARD.

3. REAR LUGGAGE BOOT.

4. BACK REST OF REAR SEAT.

5. FIREPROOF BULKHEAD.

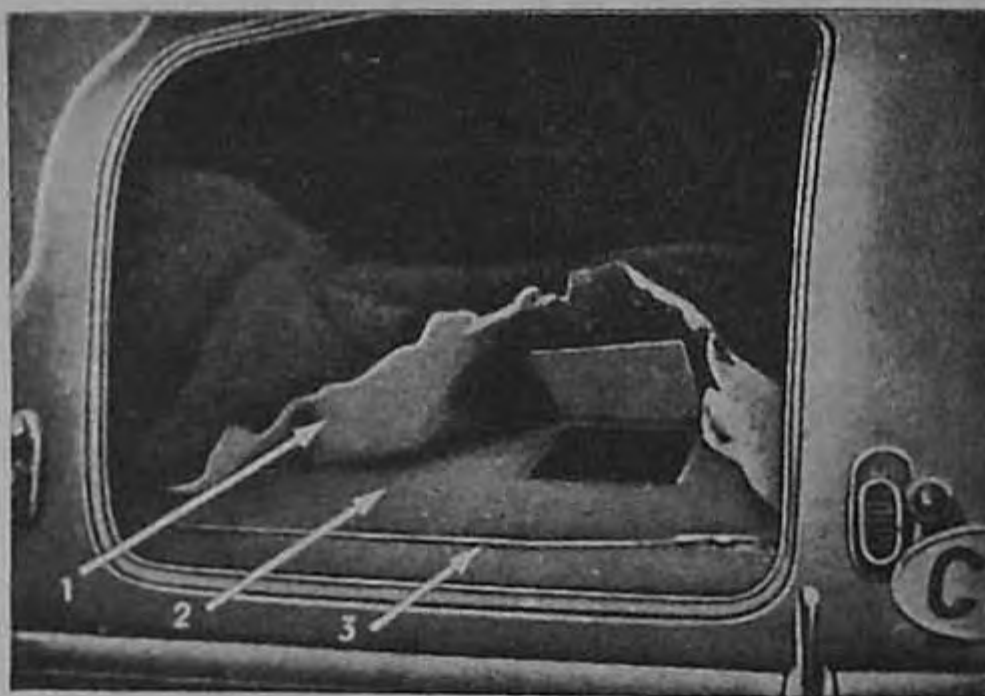
1. Detections have been made in small cavities beneath the felt in luggage boots.

In practice these were found to be difficult investigations since the felt, when removed from the metal floor plate of the boot, could not be replaced properly unless a special adhesive paste was used.

1. FELT.
2. METAL FLOOR.
3. TOOL COMPARTMENT.

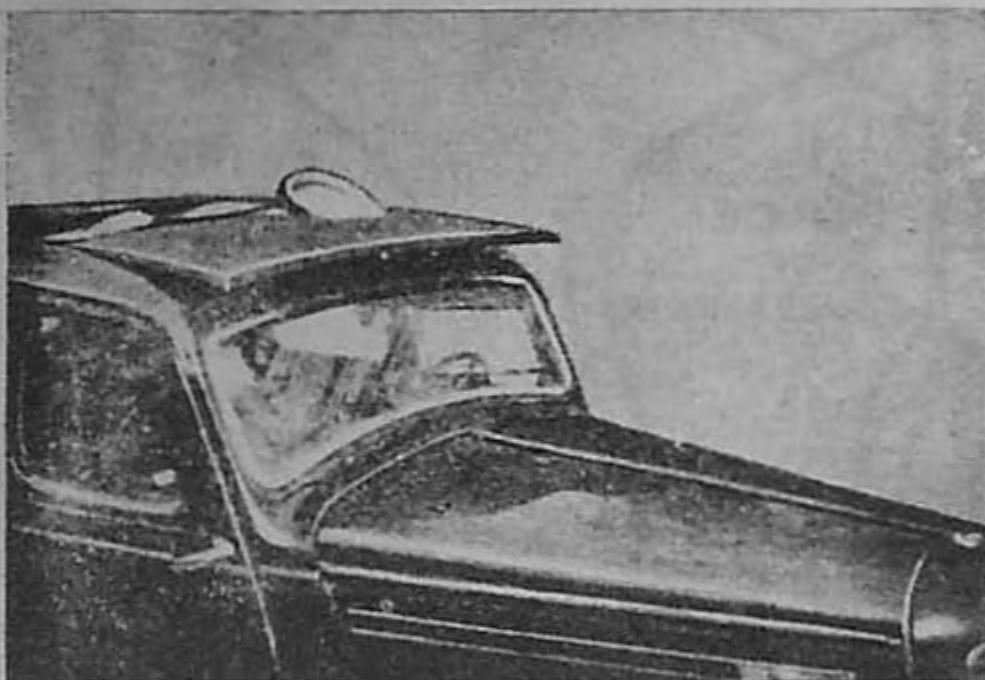
The place of concealment shown in the following illustration was discovered by the unscrewing of the retaining screws of sliding roof and moving the panel completely forward.

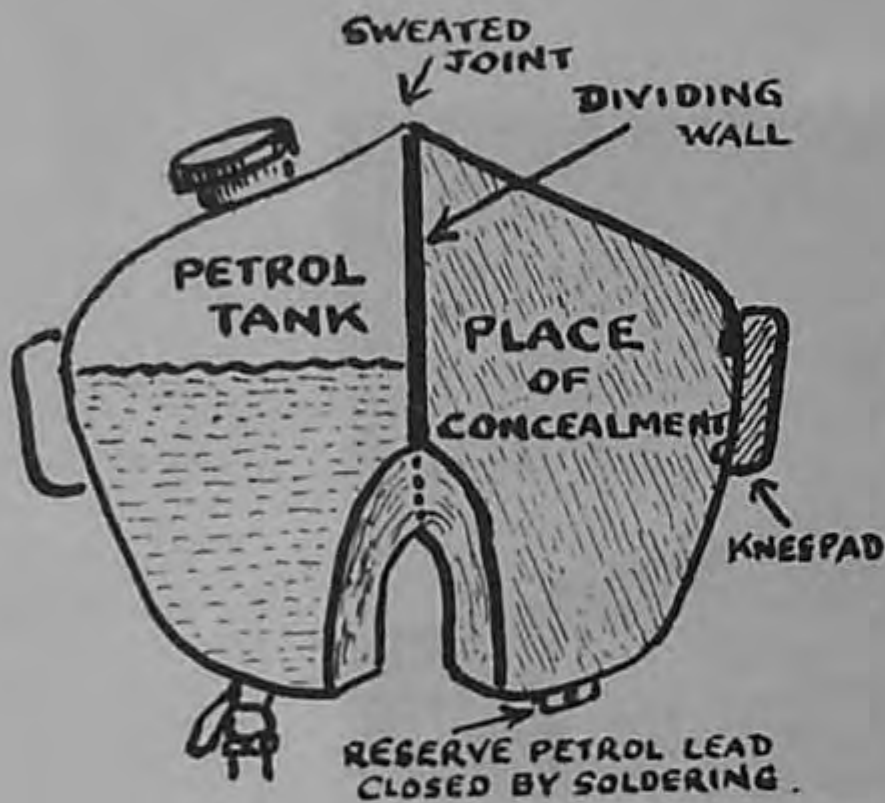
1 CROSS SECTION  
THROUGH A TANK  
of a  
ZÜNDAPP · D.B. 200

● Illustration 1. Shows that in normal use the petrol would flow out of the tank leaving a reserve quantity in the bottom right hand part. This would be the reserve quantity to the engine when the reserve feed is open. As the right hand section is a smuggling device no reserve exists and the reserve feed has been removed.

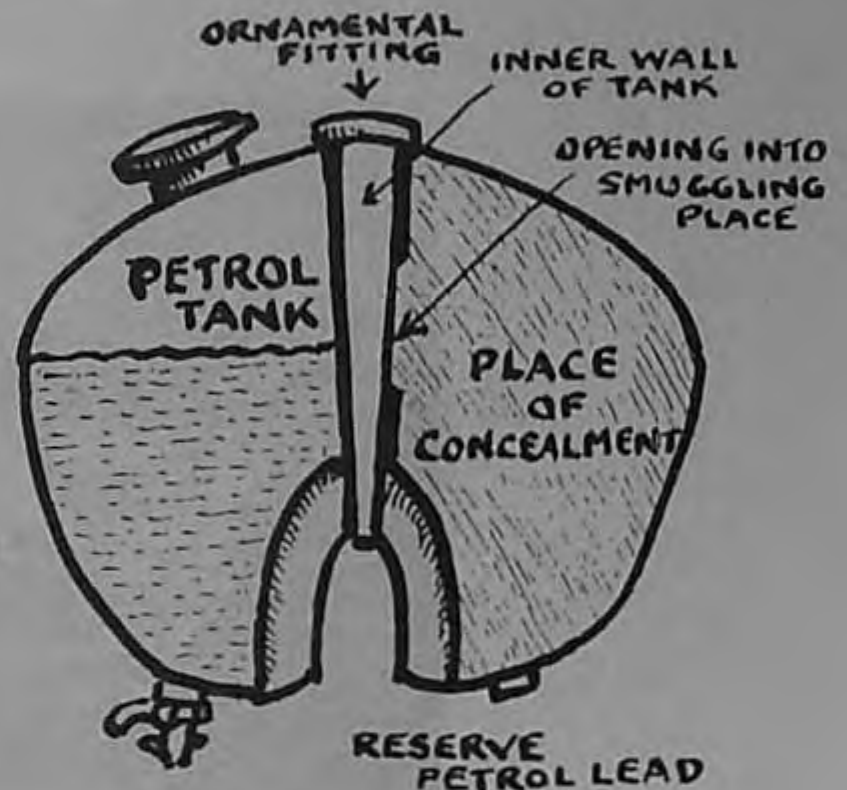
2 CROSS SECTION  
THROUGH A TANK  
of a  
D.K.W. · S.B. 200

Illustrations 2 and 3. Show a refinement of sectional tank smuggling. Here, the manufacturer had made the tank in two sections, all the right-hand section being reserve - (or at least it has to be turned on to be used) - after the left-hand section had been used. The section, once removed, was perforated as shown in illustration 3. The reserve feed, being useless was removed. If left in place it would, of course, show no petrol flow although the right-hand section of the tank would sound full.

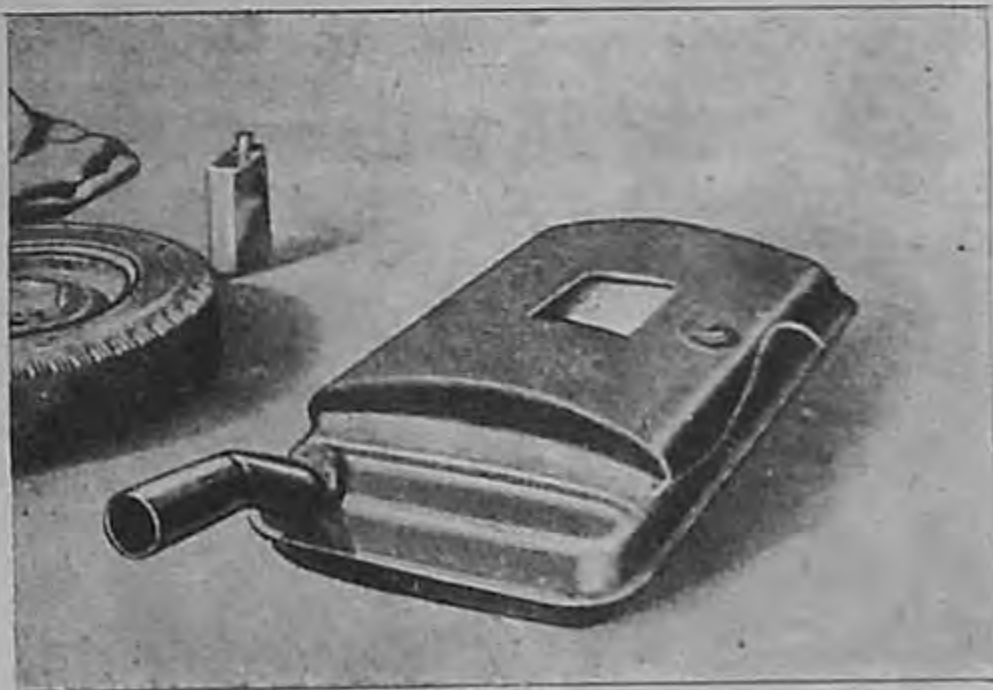
2. The motor car petrol tank shown below had had a metal plate "sweated" on to the top of it. The plate could not be seen until the tank was removed from the car.

Sounding of the tank from below would give normal re-actions.

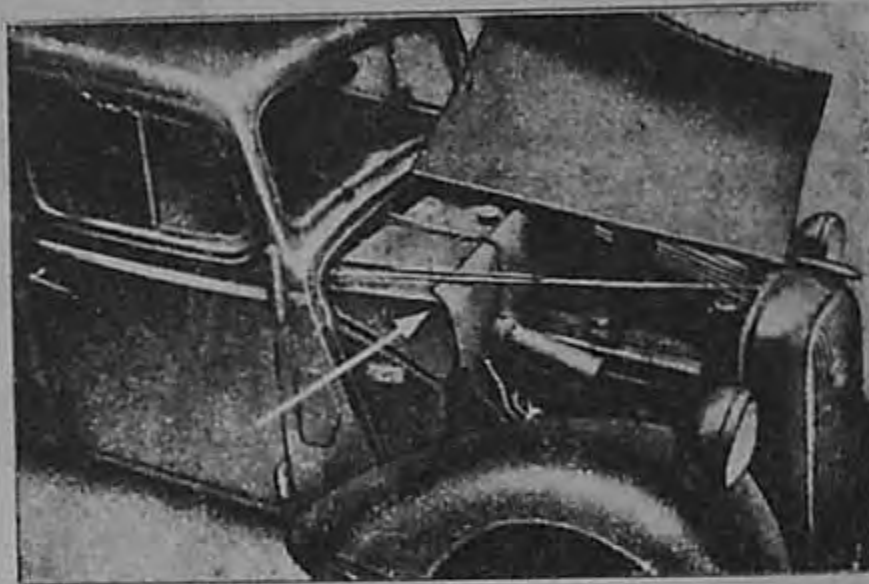
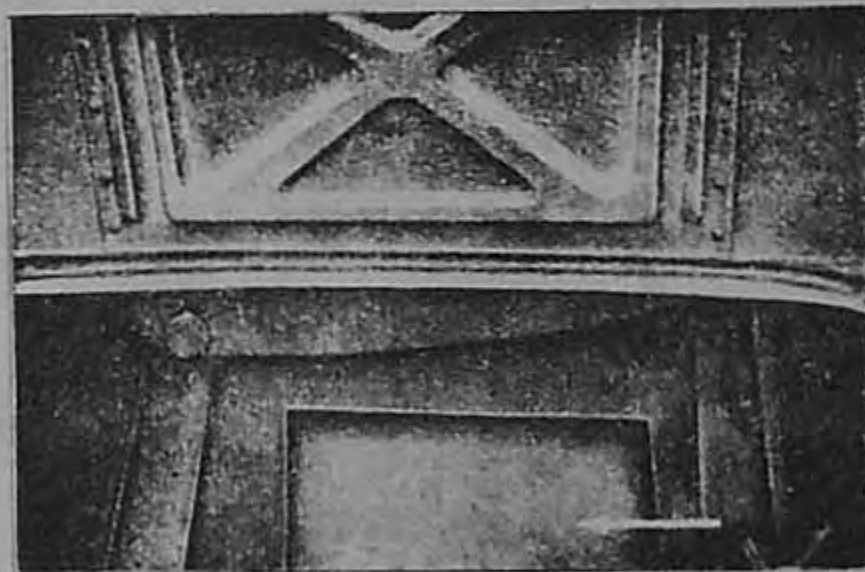
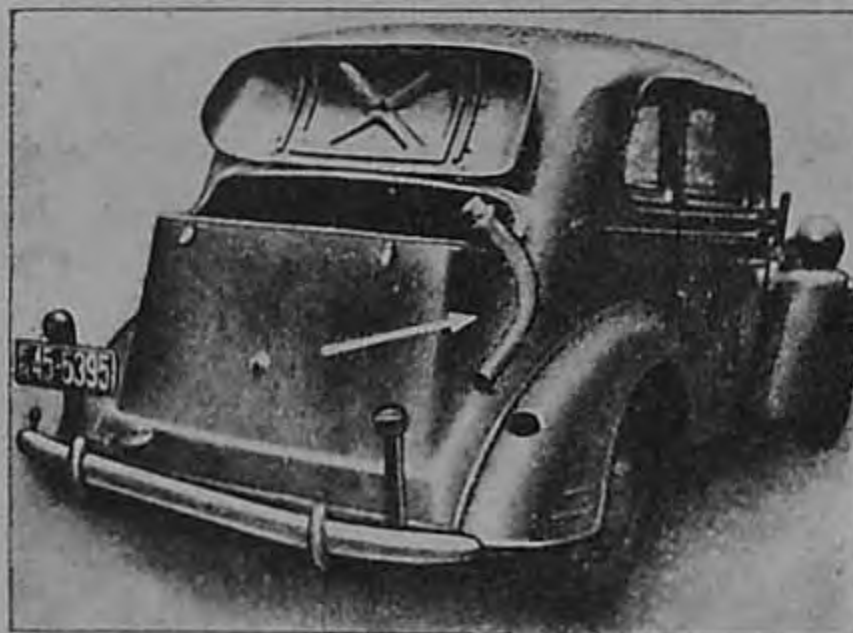
3. The following illustrations show a car which had a petrol feed from an auxiliary tank in the bonnet.

The normal petrol tank at the rear of the car was used entirely for contraband. The filler pipe was blocked at its lower end and a small quantity of petrol placed in it.

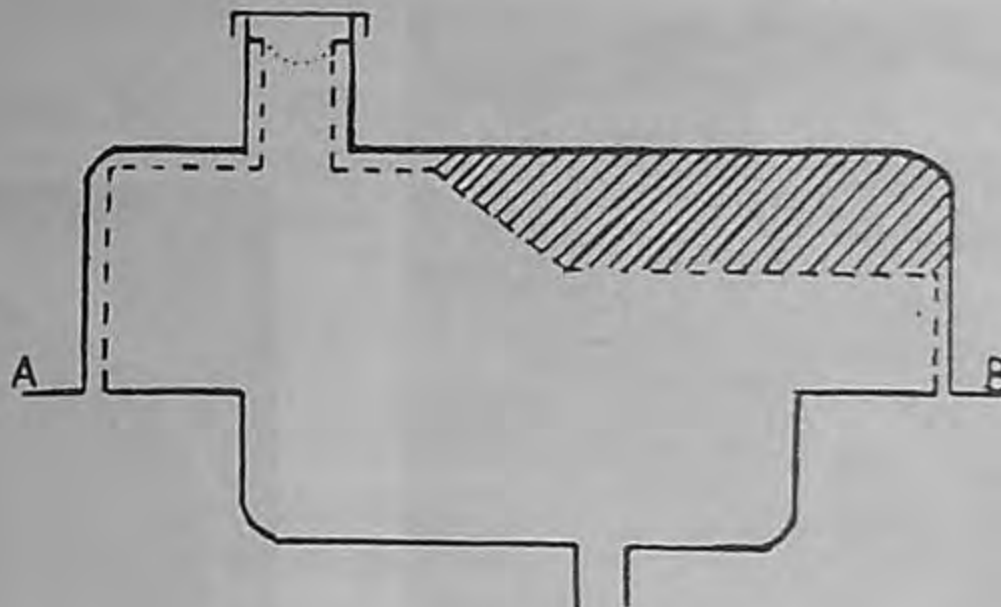
4. The following sketch is of a tank which had been cut along the line A - B. The base of the tank was used in the construction of a smaller tank which was fitted inside the remainder of the original, - as shown by the dotted lines, - leaving the shaded area as a place of concealment.

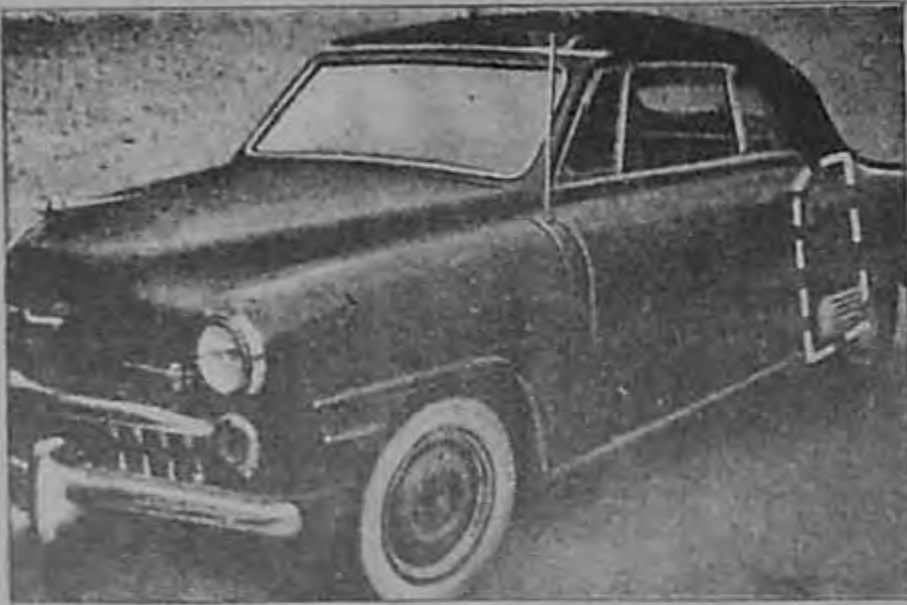
1. During the search of a STUDEBAKER-CHAMPION motor car hiding places were found inside the two rear mudguards in which 1,800 wrist watches and special watch movements of high value were concealed. The hiding places exist in every Studebaker-Champion two door model and are due to the manner of the construction of the bodywork of the car.

Illustration 1. The position of the concealment in the rear left-hand side mudguard is marked by dotted lines.

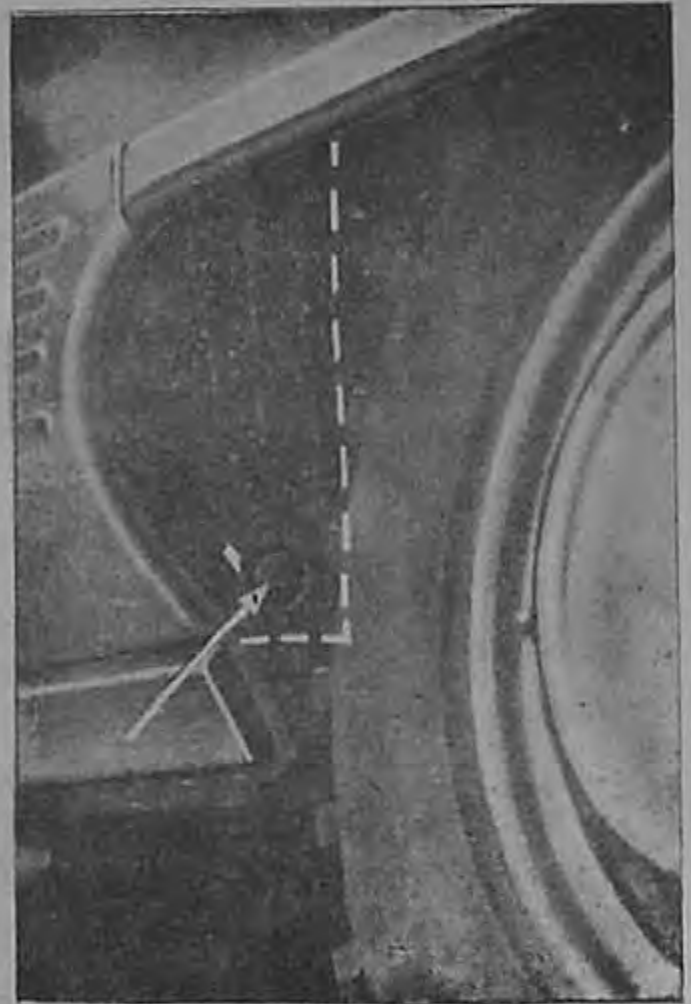
● Illustration 2. Shows the hiding place on the left-hand side in its closed-up state. In the "building - on" of the heavy mudguards hollow spaces are left between them and the bodywork of the car. The spaces are enclosed by means of tinplate covers which are fastened down by means of a hexagonal screw - (indicated by an arrow) - and fastened on the inside by means of a slotheaded screw. By reason of the dull black paintwork on the inside of the mudguards, the hiding places are difficult to detect and when the vehicle is dirty they are completely invisible.

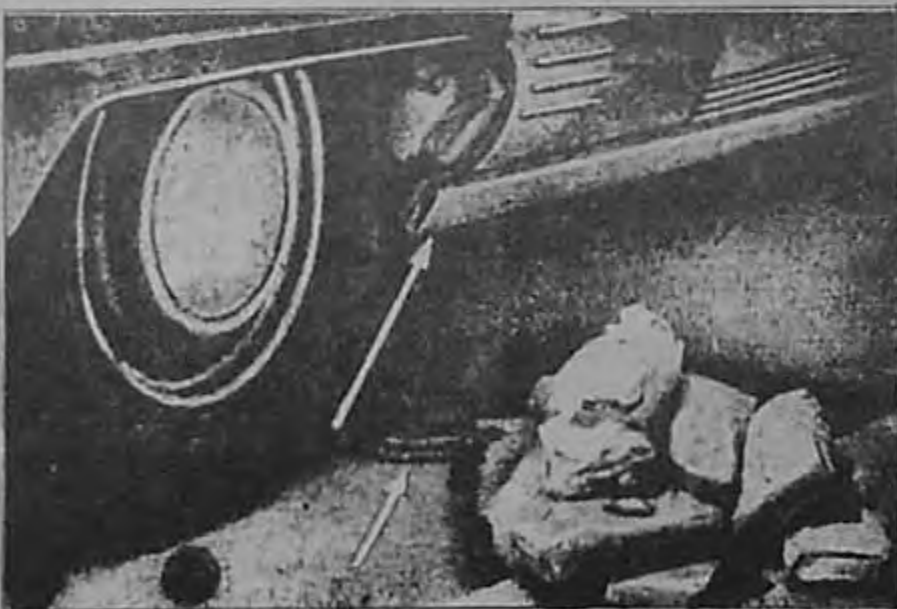
Illustration 3. Shows the right-hand side hiding place opened up together with smuggled goods. The big arrow points to the hiding place and the small arrows to the cover which has been removed.

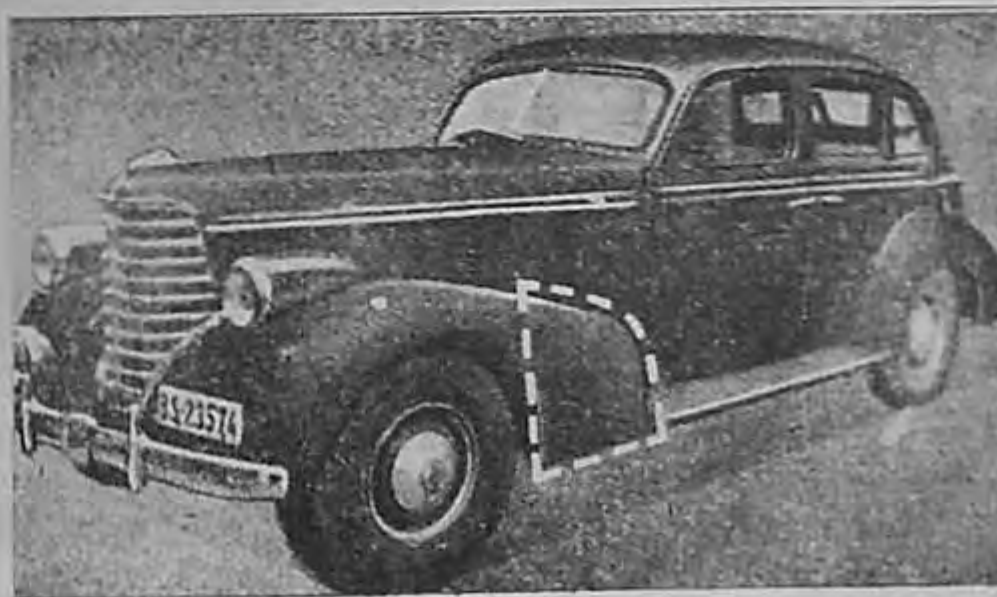
2. During the search of an Oldsmobile motor car specially constructed hiding places were found on the inside of the mudguards on both sides.

The hiding places were accessible after the bonnet had been lifted. In both places of concealment a total of 43 kilos of raw coffee was found.

Illustration 1. The dotted lines show the position of the concealments.

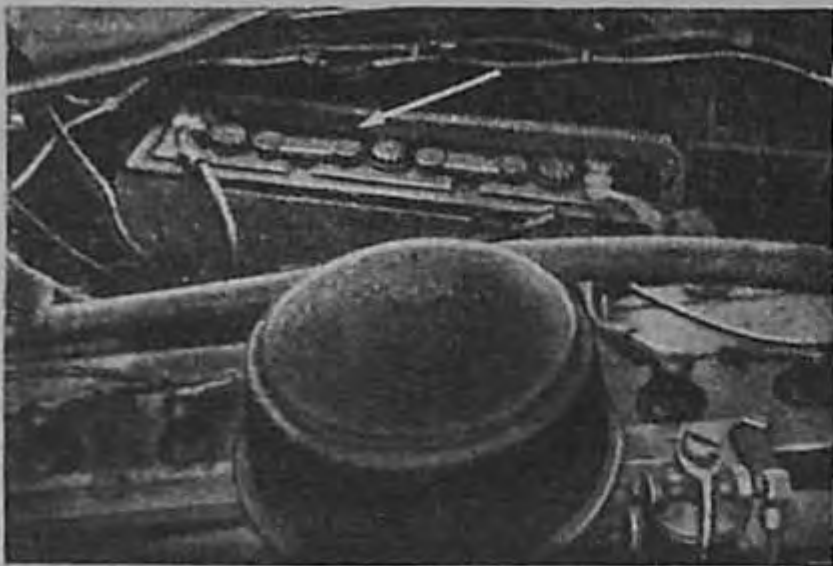
Illustration 2.

Illustrations 2 and 3. Show the entrance to the concealments closed up. The opening to the concealment on the left-hand side is behind the battery (Illustration 2), whilst the concealment on the right-hand side is closed by a tin-plate cover which is fastened down by a screw (indicated by arrow in Illustration 3).

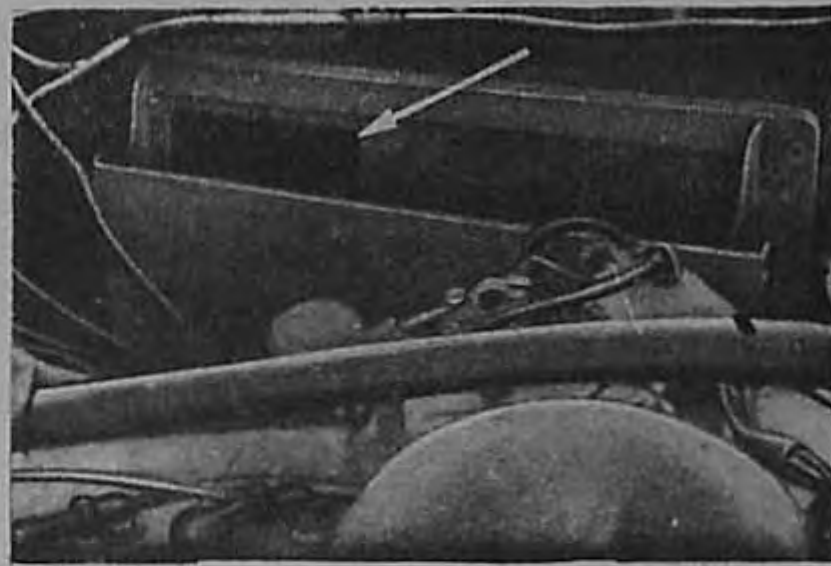
Illustration 4.

Illustrations 4 and 5. Show the concealments opened up. By the removal of the battery the opening of the concealment on the left-hand side was revealed (see arrow in Illustration 4).

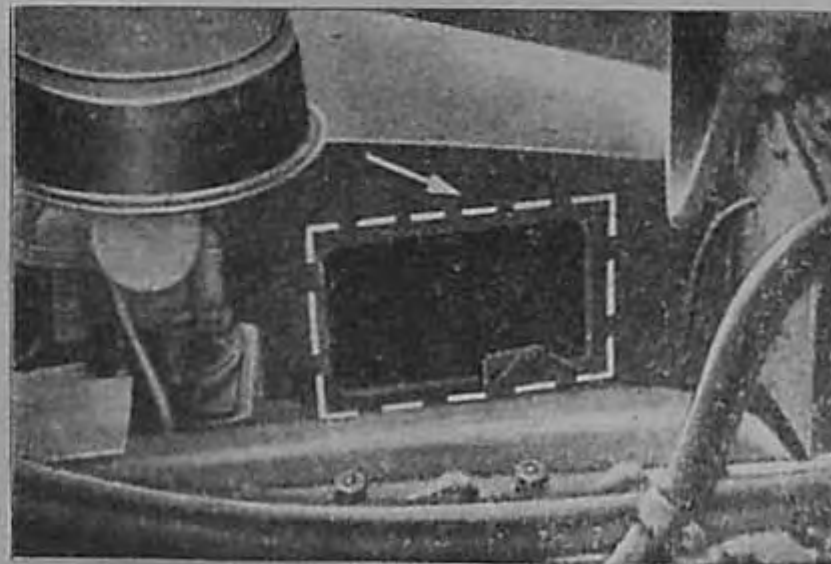
Illustration 5.

The dotted lines in Illustration 5 are around the opening of the concealment on the right-hand side.

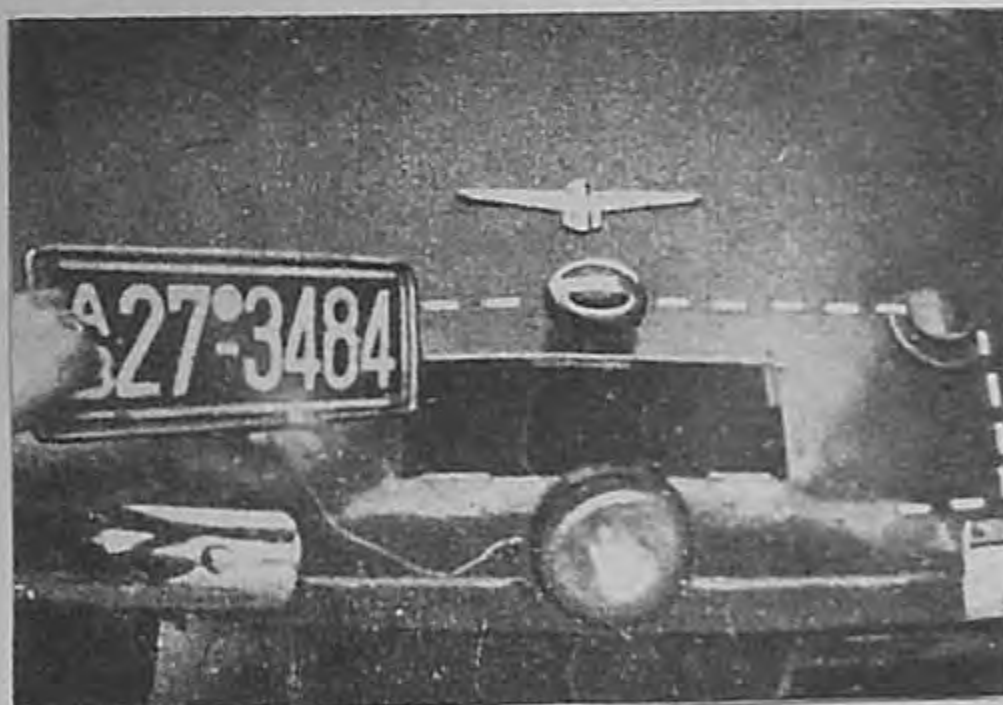
In the Adler-Autobahn motor car there is a natural space behind the rear number plates.

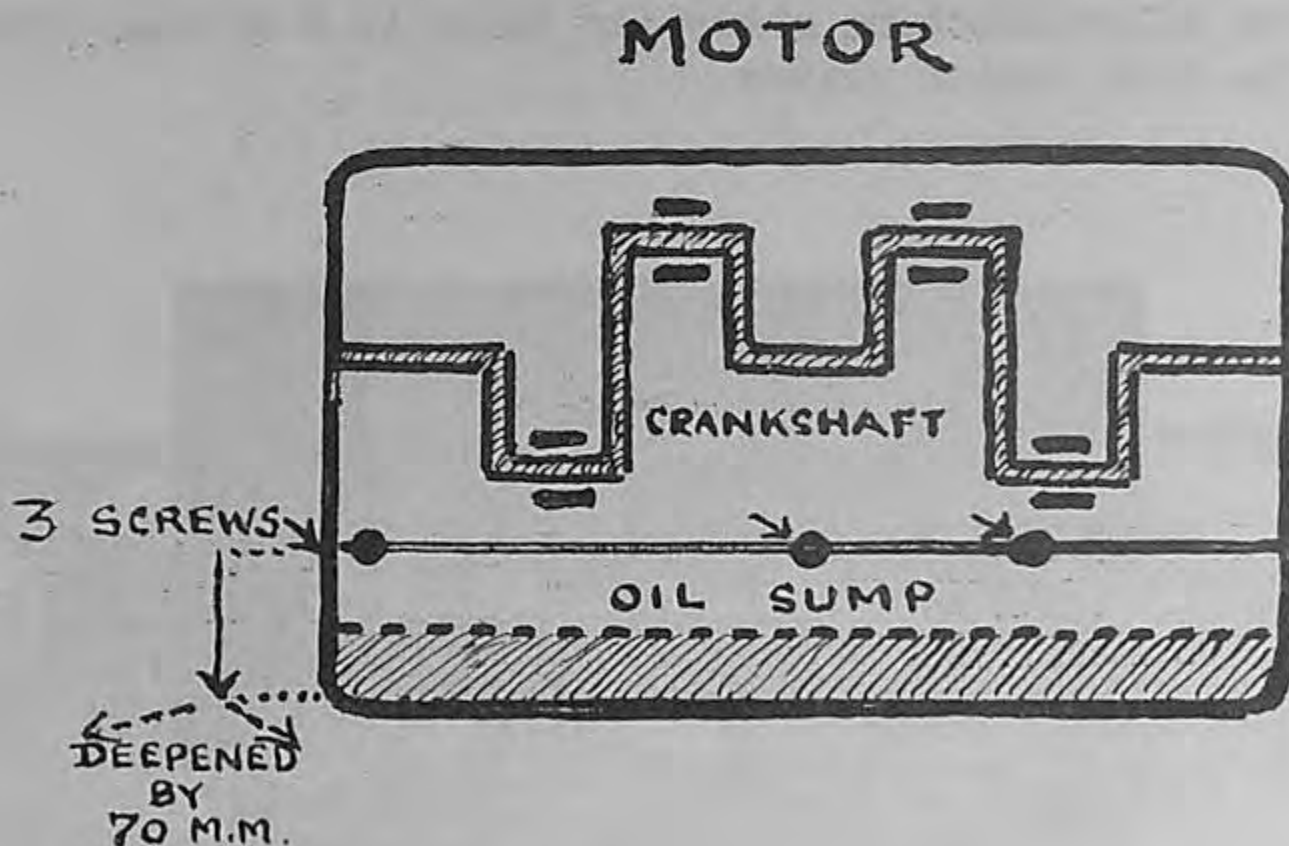
Reliable information has been received by the German Customs Authorities that many cars on the Continent have had the space in the oil sump increased by 4-7 cms. in depth.

It will be seen from the illustration that the lower part of the sump is duplicated and made deeper. The additional part can be removed by undoing the three screws.
